Cleaning sedimentation ponds at the Og (Nabbi Mussa) WWTP

Case Study

- ◆ **Client** – Mekorot Development and Enterprise Ltd.
- ◆ **Execution** – Admir Environment Ltd., 2016

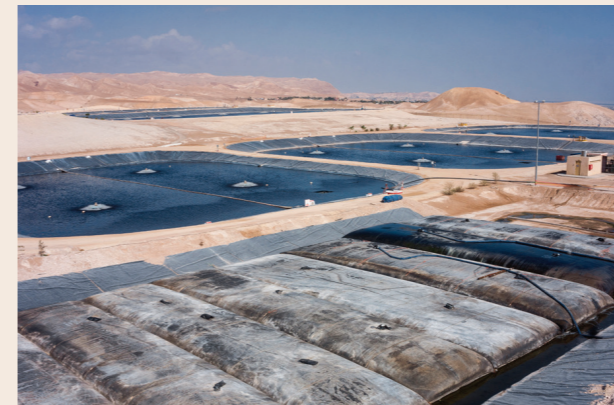
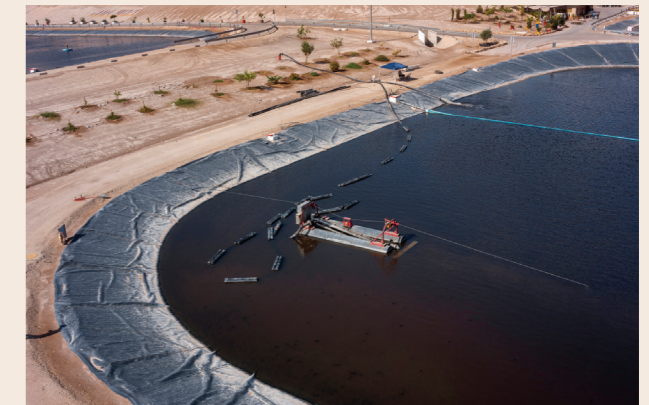
- Deploying the system on site.
- Pumping out the sediment from the bottom of the pond with a dredger into the Geotube® system while dosing with polymers to achieve flocculation.
- Returning the filtered water through the Geotubes into the pond.
- Gravitational dewatering of the sludge in the Geotubes.

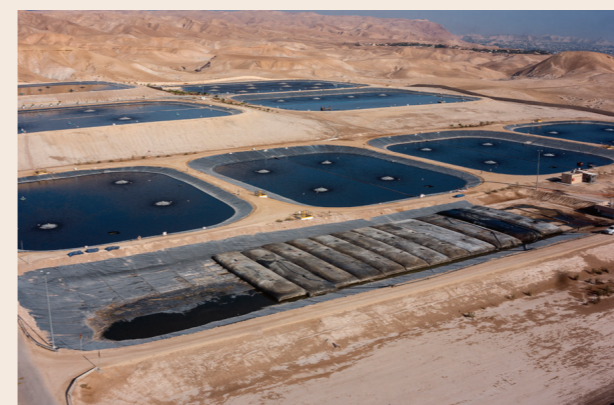
- As per requirements, the project was done without halting normal facility operations.
- About 30,000m³ of sludge were pumped from the bottom of the pond.
- The sludge volume was reduced in the Geotubes due to dewatering.
- The solid concentration received immediately after pumping out was over 25%.
- The quality of water leaving the WWTP was maintained throughout the project.
- The Geotube® sleeves were left in a spill containment system for further drying and refilling with sludge.
