# Sludge dredging and dewatering at WWTPs - Geotube® refilling

Case Study

- ◆ **Client** – Zikim WWTP, Thuvot WWTP
- ◆ **Execution** – Admir Environmen Ltd., 2014-2015

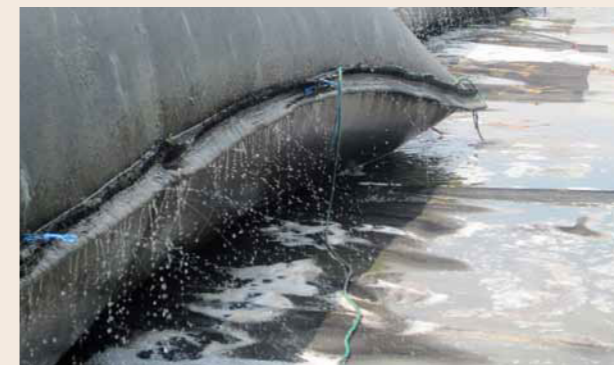
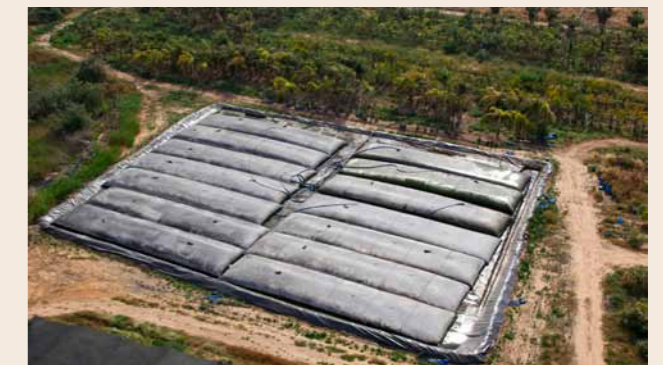
Two years earlier, a similar project was done involving sludge dewatering with Geotubes. Since the volume of the existing Geotubes decreased due to the dewatering, it was decided to reuse them and pump in additional sludge.

It was agreed that, if there is still sludge in the reservoir after refilling the existing Geotubes, additional Geotubes would be provided, to be placed as a second story over the existing Geotubes in order to complete the project. The use of preexisting infrastructures from the old project enabled to avoid new purchasing and significantly save on projects costs.
